Project 4401

Subject: **PRELIMINARY GEOLOGIC EVALUATION REPORT**
Tract 33604 and 40932
Calabasas, California

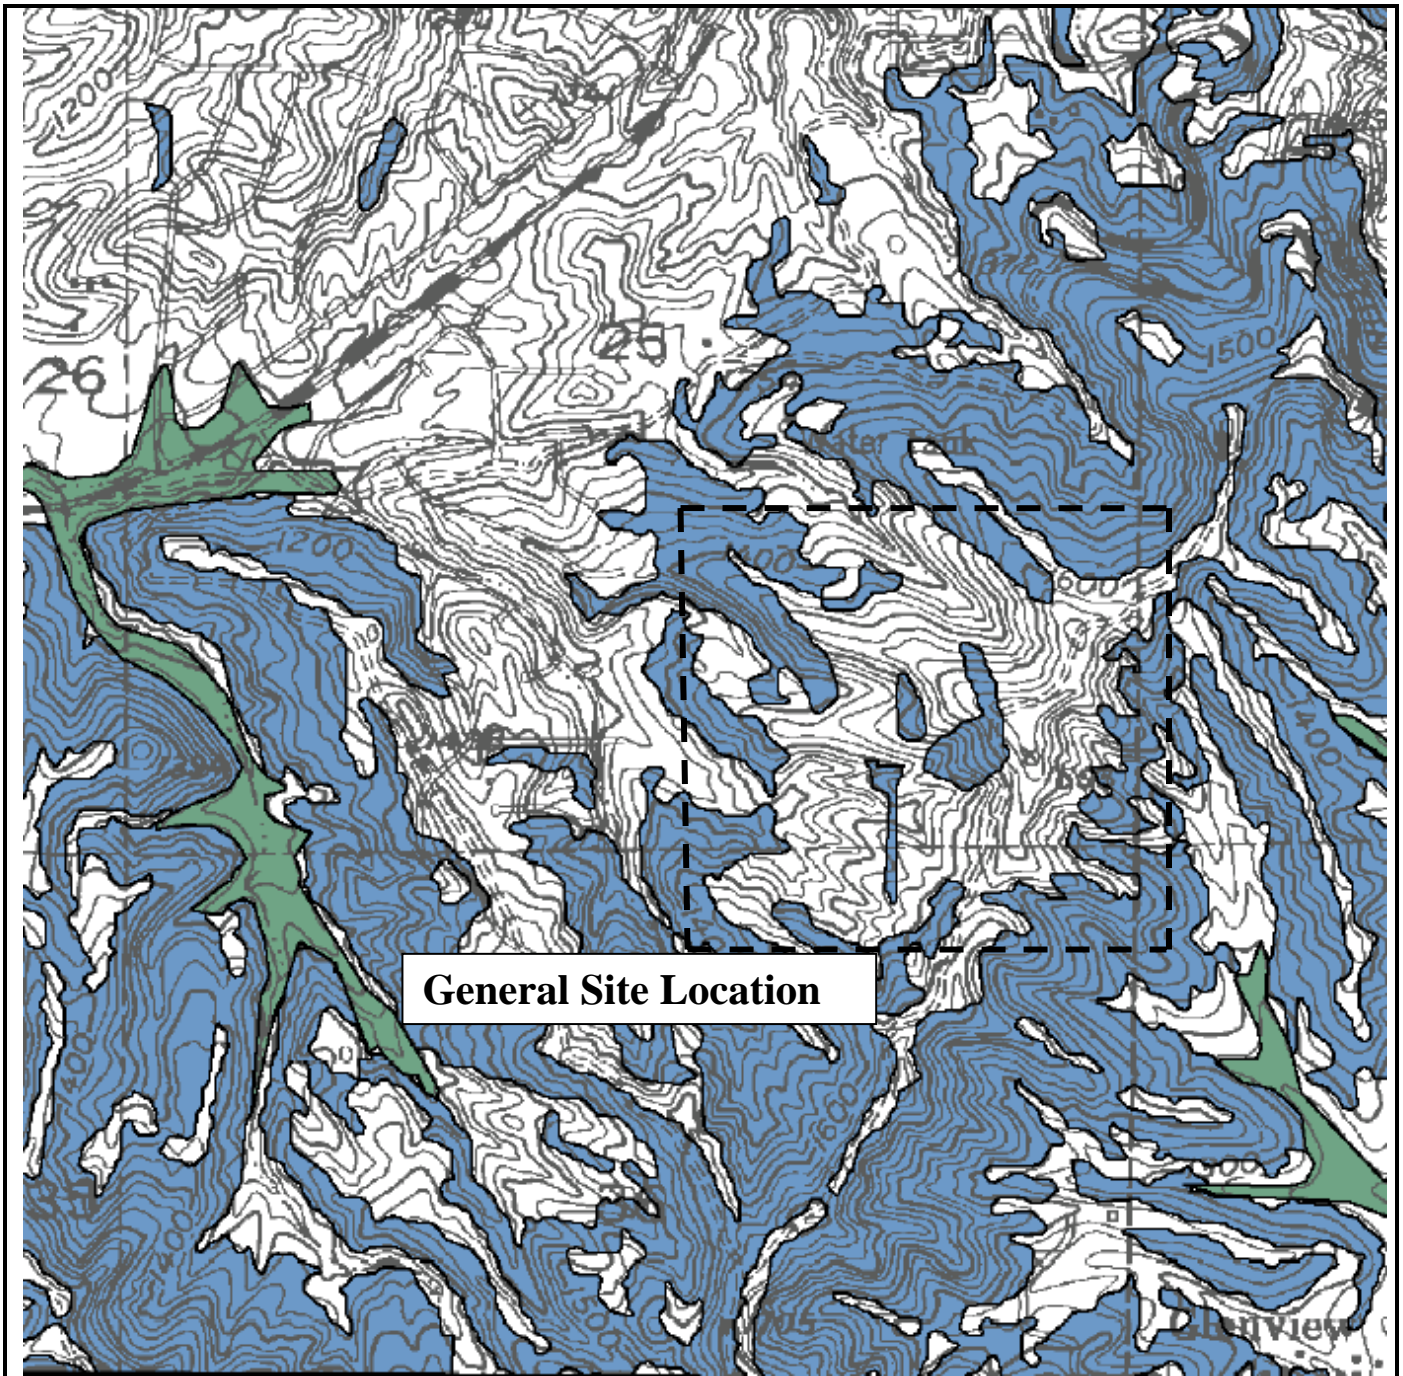
SEISMIC HAZARD MAP

Reference:	State of California
Project Address:	Tracts 33064 & 40932 Calabasas, California

Attachment: Location Map
Regional Geologic Map, Plate 1
Regional Hazard Map, Plate 2
Geologic Map (pocket attachment)
